*Cocoa Beach*  
*Report 4*

*Stormwater Filtration Systems*

## Cocoa Beach Report 4

**Release Date: May 15, 2000 – Service Date: April 17 & 25, 2000**

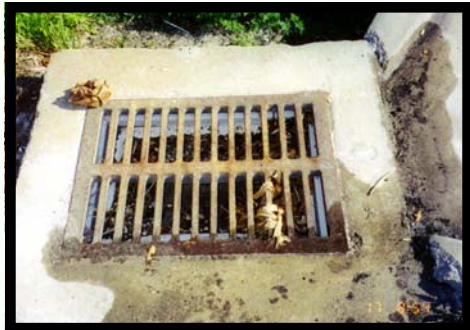
**Left:** View of inlet prior to any service work. It is a standard “C” type inlet.

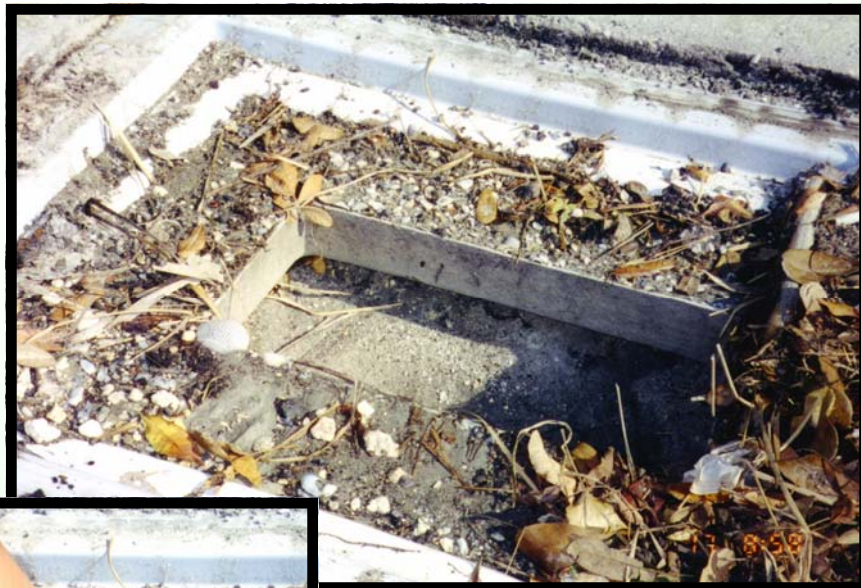
**Below:** Immediately after the grate is removed, it can be observed that the *Grate Inlet Skimmer Box* is nearly full with sediment and foliage.

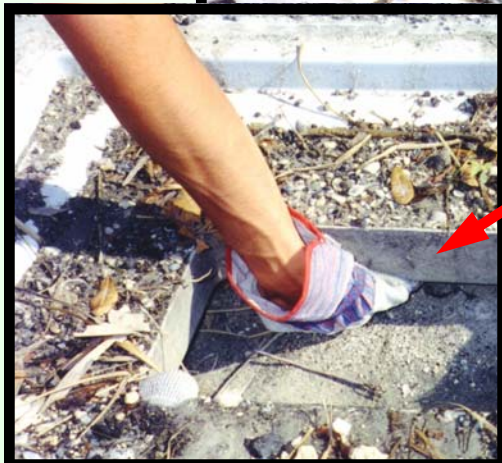
**Skimmer Tray**

**Left:** The lower filtration chamber is filled up to within approximately 3” of the bottom of the skimmer tray. A man’s hand can easily fit between the skimmer tray and the sediment collected within the lower filtration chamber.

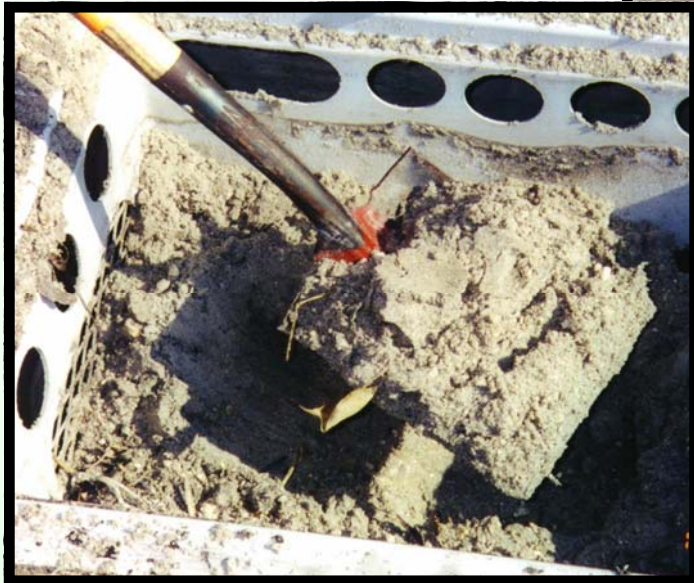
**Left:** A standard square shovel was used to remove most of the sediment and foliage from the lower filtration chamber.

The weight of the debris collected from this inlet was 481 pounds with a volume of 163 quarts. It is estimated that the weight is composed of approximately 5% foliage and 95% sediment.

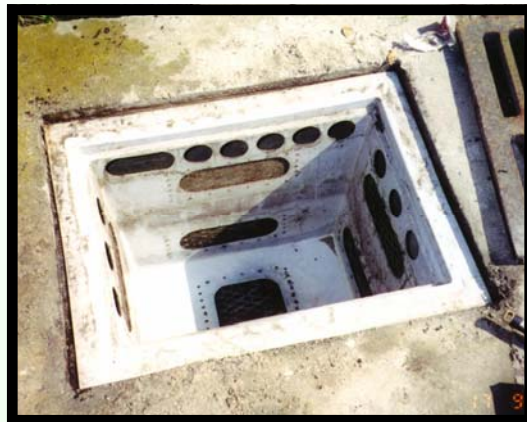
**Right:** The *Grate Inlet Skimmer Box* has been emptied. The skimmer tray and deflection shield assembly is ready to be re-installed, and the grate placed back over the inlet.

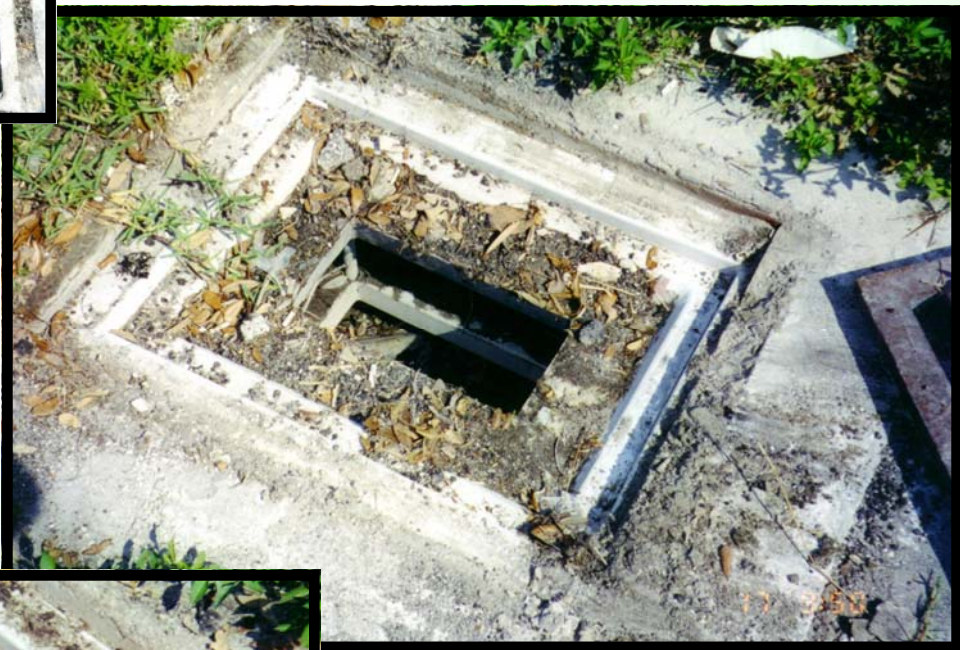
**Below:** Immediately after the grate was removed.

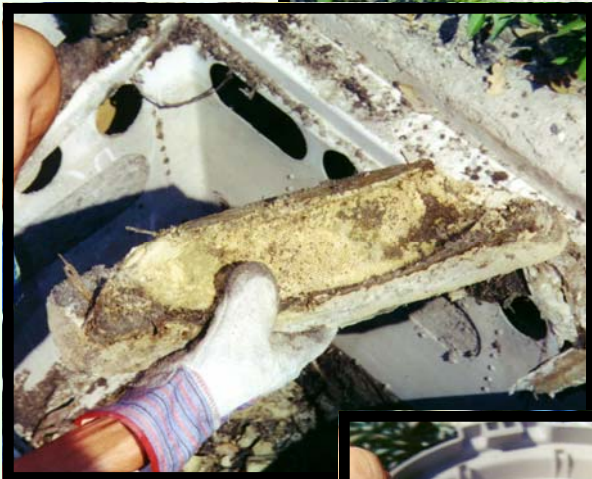
**Left:** The sediment collected in the skimmer tray solidified with the consistency of hardened mortar.

The weight of the debris collected from this inlet was 179 pounds, with a volume of 89 quarts. It is estimated that the weight is composed of approximately 5% foliage and 95% sediment.

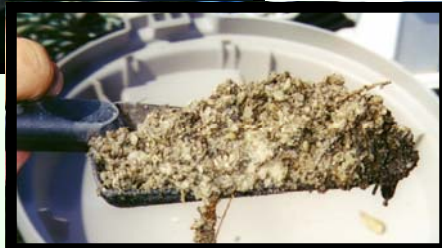
**Left:** Much of the sediment in the lower filtration chamber was a coarse shell type material.

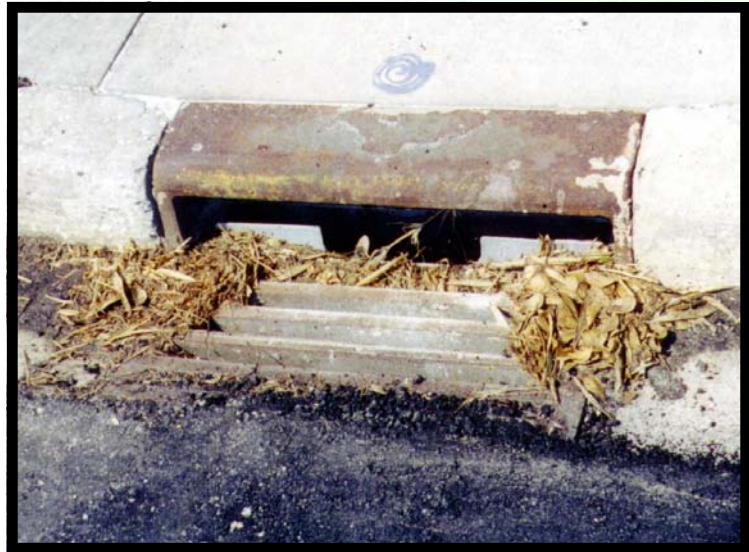
This is a grated curb inlet, adjacent to a sidewalk in a residential neighborhood. The road was resurfaced a few days before. Much of the collected sediment was ground up asphalt from the recent road work.

**Above:** View of inlet prior to any service work.

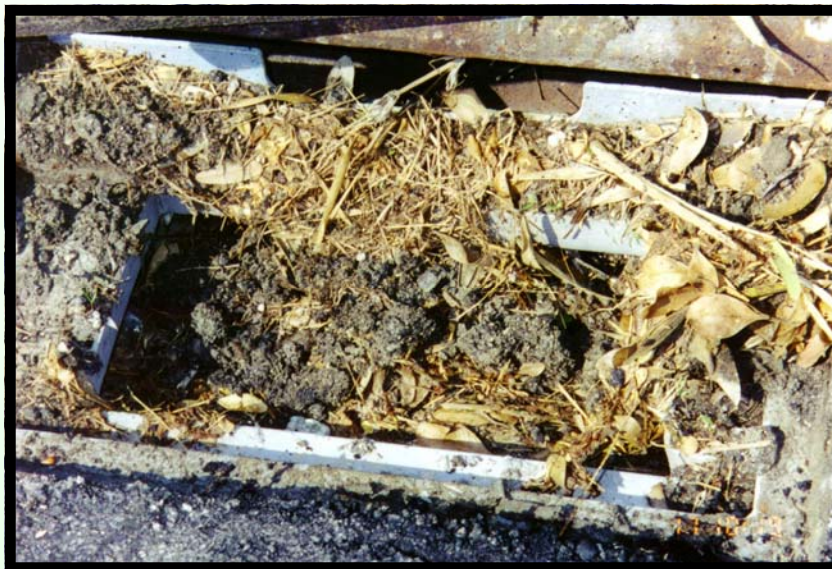
The weight of the debris collected from this inlet was 72 pounds, with a volume of 23 quarts. It is estimated that the weight is composed of approximately 5% foliage and 95% sediment.

**Above:** Inlet immediately after the grate was removed.  
This *Grate Inlet Skimmer Box* measures only 11"

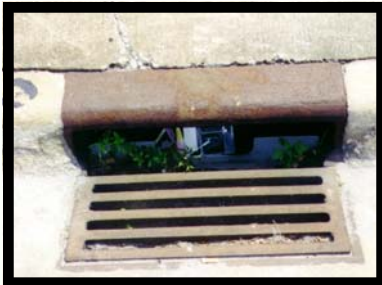
**Left:** View of grated curb inlet prior to any service work.

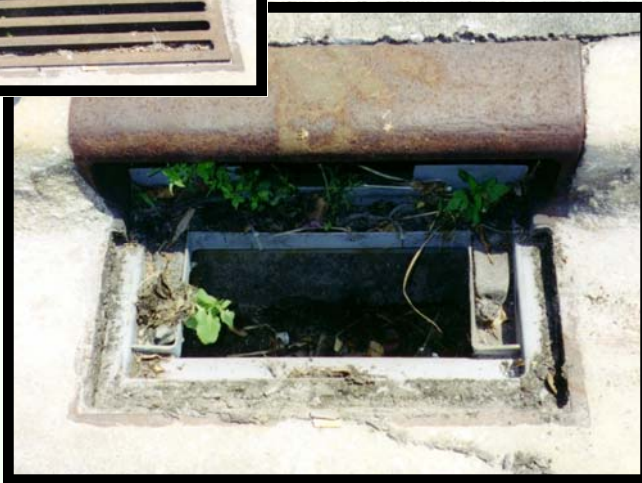
**Below:** Immediately after the

This grated curb inlet is located along the East side of Brevard Ave., and is adjacent to a very large townhouse complex. The townhouse complex has very little pervious ground, and it is approximately 518 feet to the next stormwater inlet along the East Side of Brevard Ave. It is estimated that the watershed entering this inlet is above average for the area.

The weight of the debris collected from this inlet was 42 pounds, with a volume of 19 quarts. It is estimated that the weight is composed of approximately 5% foliage and 94% sediment.

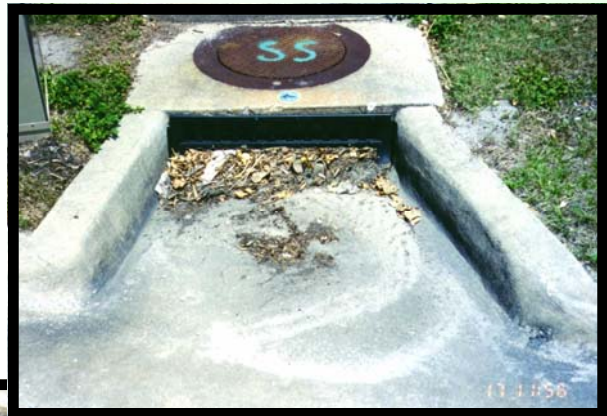
This inlet is located at the end of a short flume. The weight of the debris collected from this inlet was 17 pounds, with a volume of 18 quarts. It is estimated that the weight is composed of approximately 60% foliage and 40% sediment.

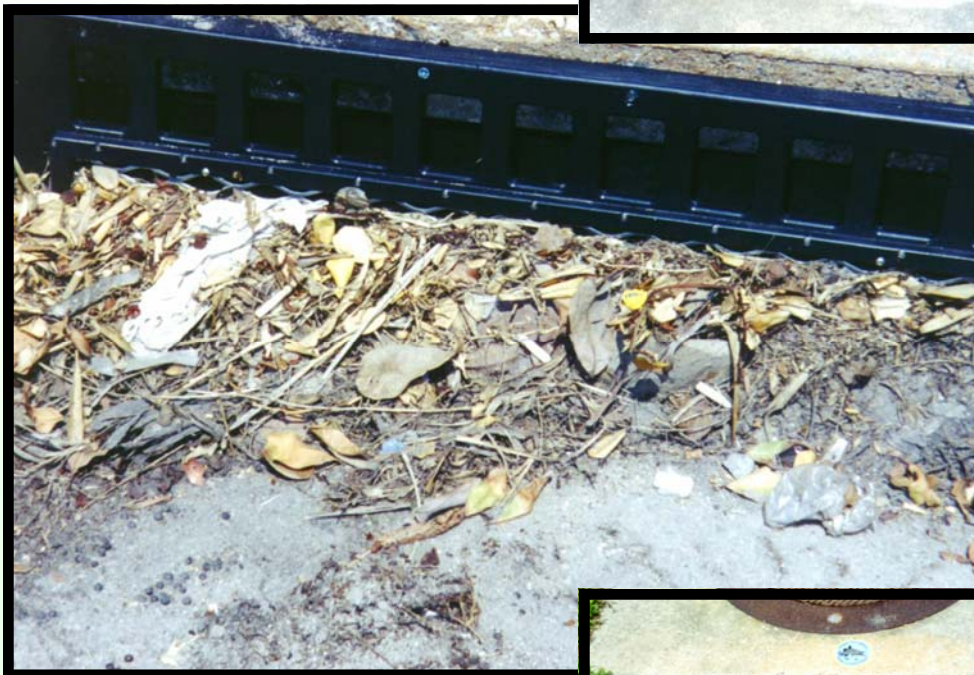
**Above:** A close-up of the collected debris, all of which would have washed into the storm drain if the Curb Protector had not been in place.

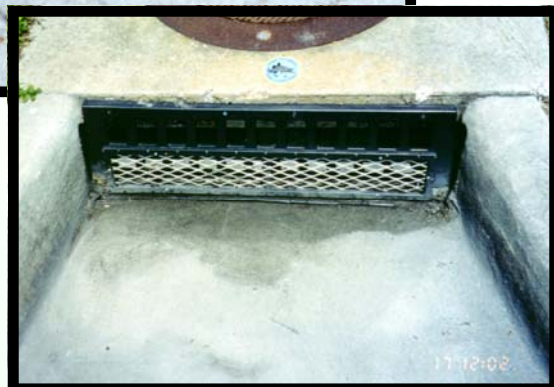
**Right:** The inlet has been cleaned and is ready for the next storm event.

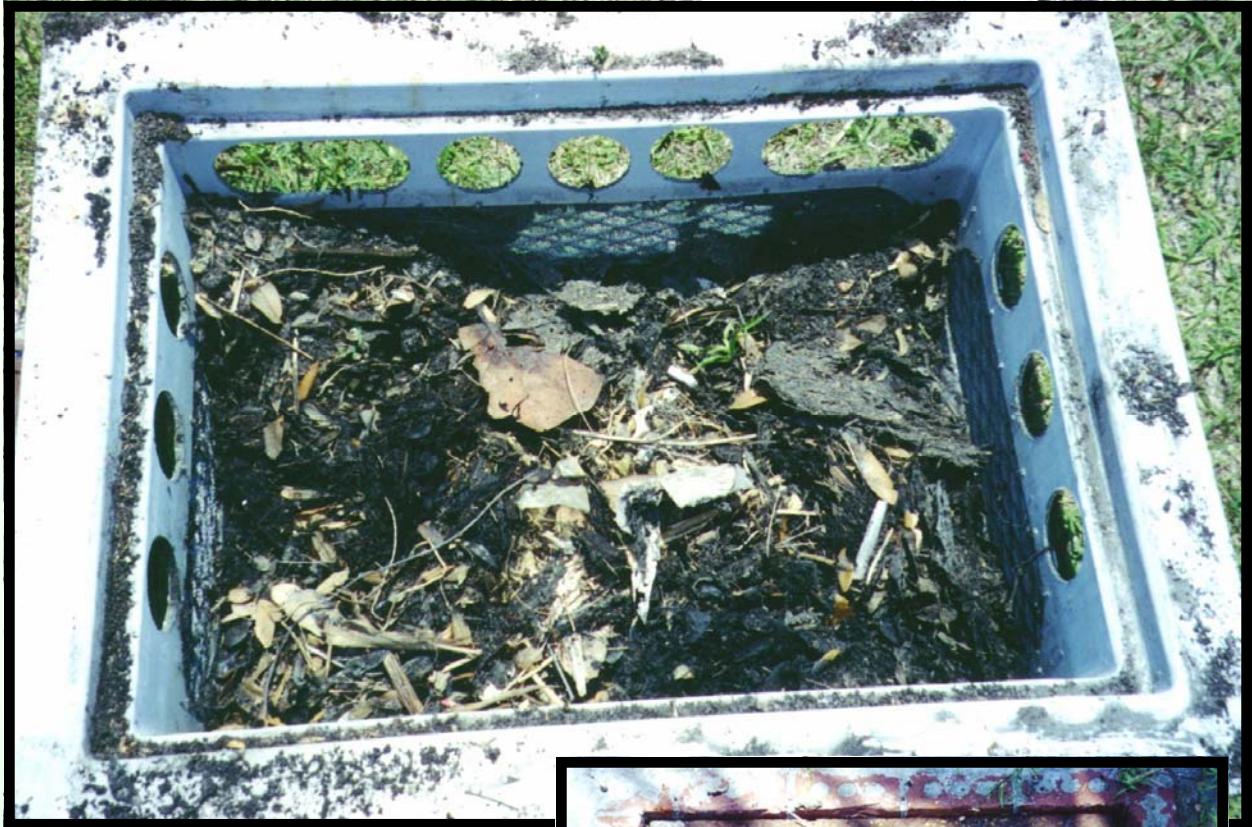
This is a standard “C” type inlet. The weight of the debris collected from this inlet was 18 pounds with a volume of 33 quarts. It is estimated that the weight is composed of approximately 70% foliage and 30% sediment. This *Grate Inlet Skimmer Box* measures only 12 inches deep, demonstrating the effectiveness in shallow applications.

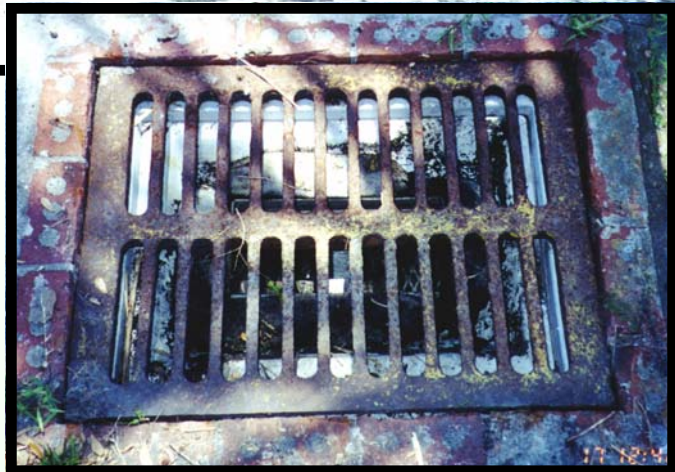
**Above:** The *Grate Inlet Skimmer Box* has been cleaned and the inlet is ready for the next storm event.

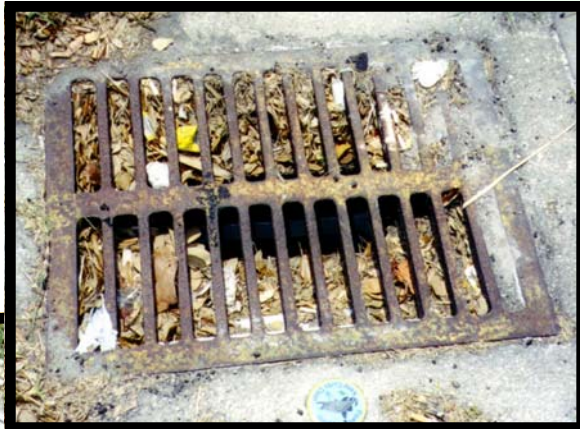
**Right:** View of inlet prior to any service. This is a standard “C” type inlet.

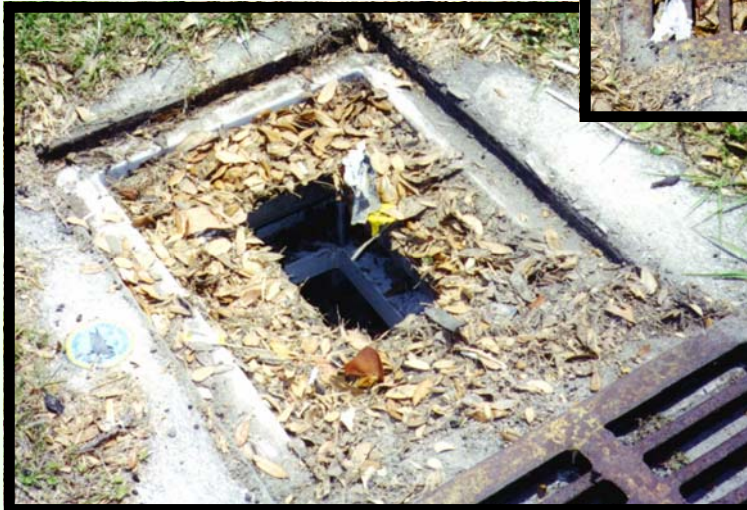
**Below:** Immediately after the grate was removed.

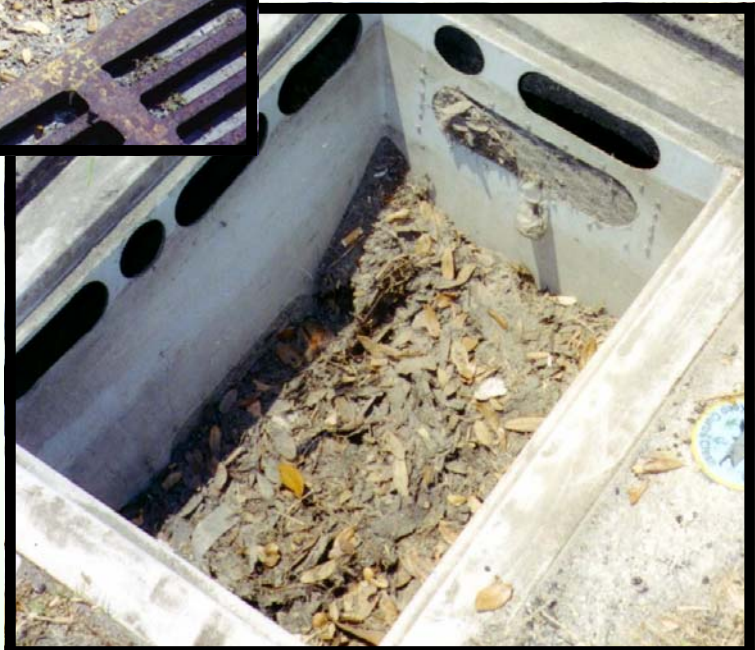
**Below:** Debris collected inside lower filtration chamber.

The weight of the debris collected from this inlet was 26 pounds with a volume of 33 quarts. It is estimated that the weight is composed of approximately 60% foliage and 40% sediment.
