CASE STUDY

Volume 10
Number 1
April 2007

Residential Drainage Channel Protected with P550 C-TRM

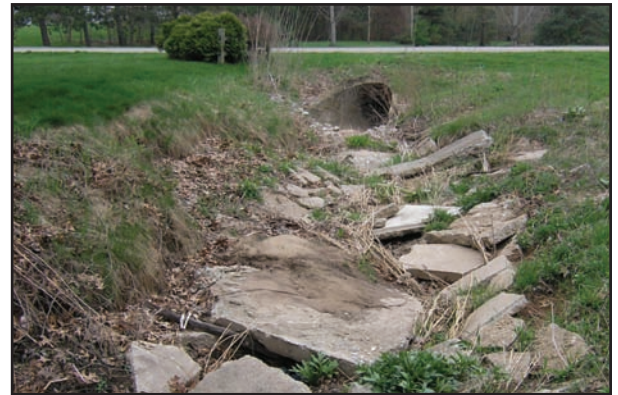
Before the re-design, the existing drainage channel was lined with broken concrete slabs, and erosion was occurring in the channel.

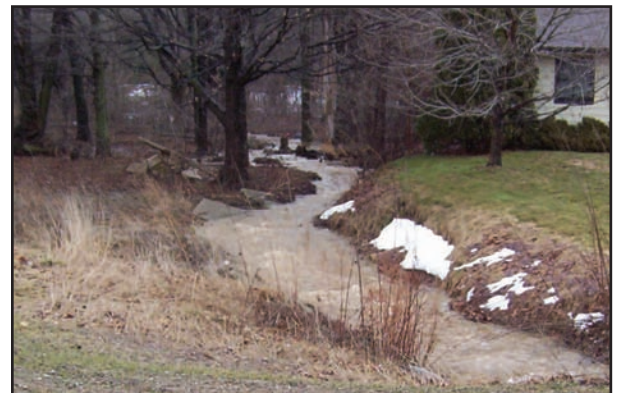
During heavy rain events, the large amounts of stormwater runoff flowing over the broken concrete slabs were creating unnecessary turbulence and added to the erosion process.

Initially the stormwater runoff from the new development was to be diverted into an existing channel currently serving the established neighborhood. While this plan elevated the need to construct a new drainage channel, the developers had concerns as to whether the existing channel could sustain the additional runoff quantities. The local engineering firm, Medema, VanKooten & Assoc. analyzed the present channel consisting of broken concrete and confirmed that it would not withstand the additional volume of stormwater from the new subdivision, and that without additional engineering the channel in time would washout under the increased flows.

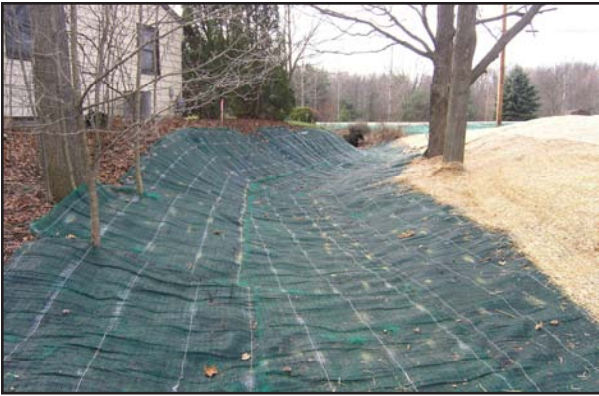
The P550 turf reinforcement mat provided the erosion protection needed in the channel.

After consulting with North American Green's authorized distributor Price & Company, North American Green's P550, a polypropylene fiber filled composite turf reinforcement mat (C-TRM), was chosen for the project. The P550 is a C-TRM comprised of a permanent, ultra-high strength three-dimensional matting structure incorporated with a 100% polypropylene fiber matrix. The P550 is designed to provide both long-term, pre-vegetated erosion protection and permanent vegetation reinforcement.

Before installation of the P550, four inches of topsoil were added to the channel, improving the sandy loam soil bed. Then the entire channel surface was seeded and fertilized. A standard turfgrass mix was chosen for the site. Sod forming grass was chosen for its potential to increase the erosion control in the channel as well as the ease in maintaining the vegetation in the residential area. After seedbed preparation, the P550 was installed in the channel bottom and along the side slopes.

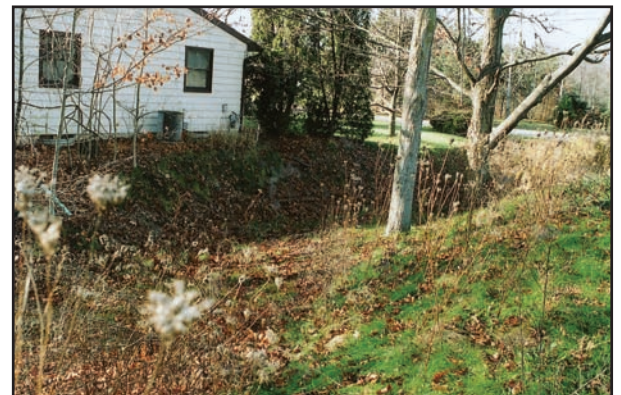
Within one growing season, the P550 had vegetated, leaving a natural channel bed that was pleasing to the nearby residents. The removal of the concrete also aided in easier maintenance and improved flow conveyance.

The high performance of the P550 became apparent soon after installation as just before vegetation had established, three large rain events occurred each dumping several inches of water. The P550 withstood excessive discharge rates, and protected both the soil and seed from erosion. The project was started in June 2005, and by the end of that growing season the vegetation had matured in the channel.
